Completing the Engine Installation

By Pete Dubler

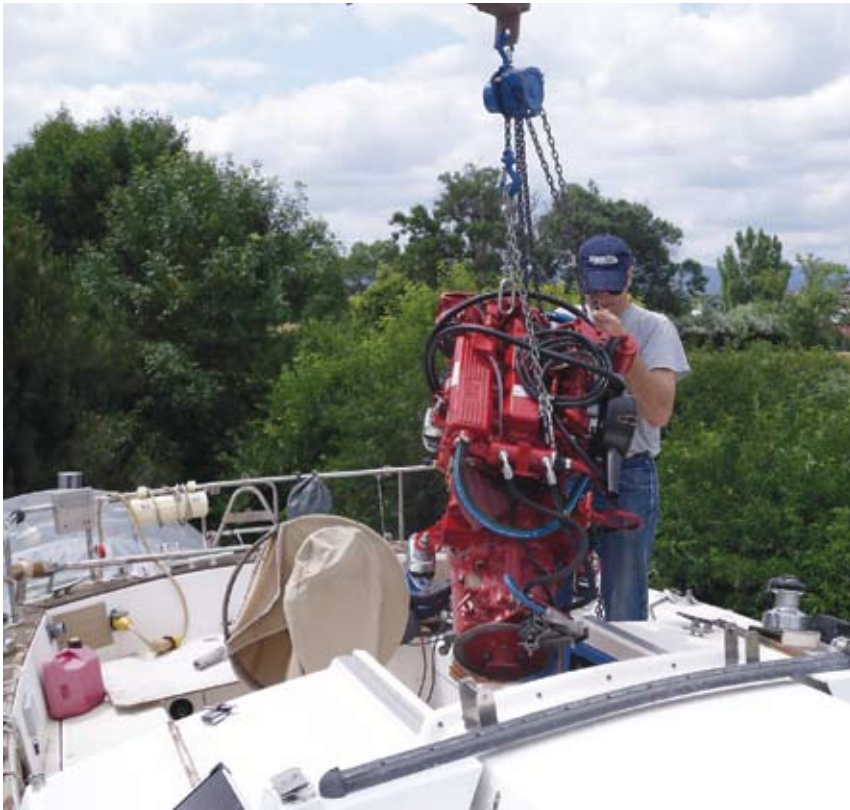
In order to test the fit of the engine and align the mounting holes of the new engine bed, I constructed a wooden mockup of the engine

with its accessories. This provided exact positioning of the vibration mounts and the driveshaft and did not require the shop crane to move around. The mockup was invaluable, as it exposed the fact that the engine bed had to be lowered by 3 1/4". As it turns out, the old engine mounts were not on the plane of the crankshaft, but rather were vertically offset to lower the engine. I had missed this detail when specifying the engine.

This proved to be a blessing, as when I cut the top few inches off the old fiberglass bed, it became apparent just how flimsy it was. While the cross section of the bed was upwards of 1/2" thick at the top, where I cut was closer to 1/4" thick. I would not depend on that to properly support the engine.

For the new bed, I used 3/8" thick angle iron, onto which I welded angles to abut the lateral beams of the engine compartment. The new bed was bolted with 3/8" bolts through the beams and to the old engine bed in six places on each side. To ease the engine installation, holes were pre-drilled and tapped for the vibration

mounts. Where the mounting hole was over a beam, a stud was installed and welded into the tapped hole.
